MICHIGAN DEPARTMENT OF TRANSPORTATION

STR 8249

BRIDGE SAFETY INSPECTION REPORT

Facility SOUTH STREET	Latitude / Longitude 42.8482 / -83.4469	MDOT Structure ID 634505000112B01	Structure Condition Good Condition(8)

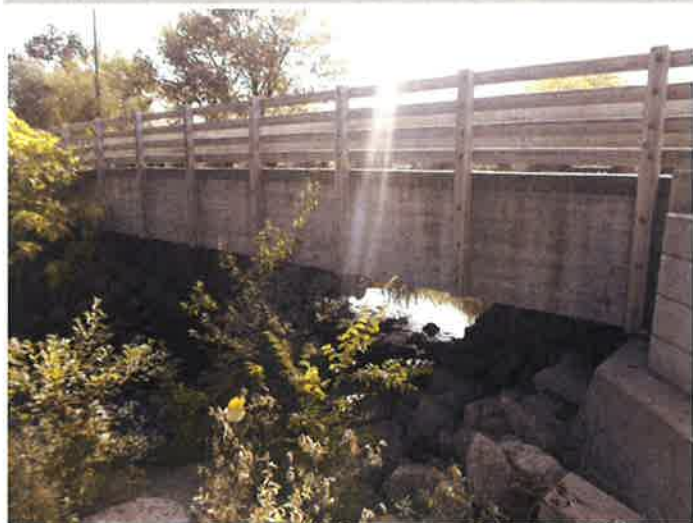
Document Name: DSCN0429.JPG
 Category: Elevation
 Comments:

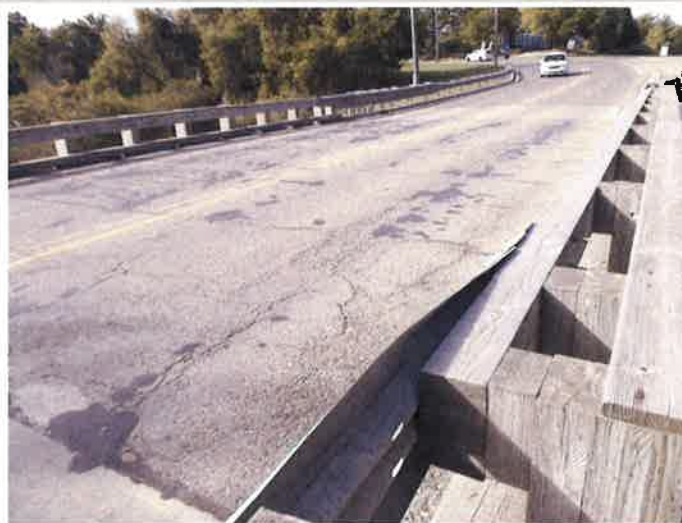
09/13	09/15	09/17	
1. Surface (SIA-58A)	6	5	5	HMA surface. Transverse cracks spaced at approx. 4 ft at deck panel joints. Some longitudinal cracks. Map cracking throughout. Some cracks are sealed. There are some longitudinal ruts. (09/17) HMA surface. Transverse cracks spaced at approx. 4 ft at deck panel joints. Some longitudinal cracks. Map cracking throughout. Some cracks are sealed. There are some longitudinal ruts. (09/15) HMA surface. Transverse cracks spaced at approx. 4 ft at deck panel joints. Some longitudinal cracks. Map cracking along transverse and longitudinal cracks. Some cracks are sealed. There are some longitudinal ruts. (09/13)

Document Name: DSCN0428.JPG
 Category: Deck
 Comments:

Recommendation Type	Priority	Description
Brush Cut	L	Keep brush around bridge/drainage structure outfalls trimmed back.
Railing Repair	L	Repair impacted guardrail.
Joint Repair	H	Reseal E3 joints at the ends of the bridge.
Overlay	H	Mill and overlay with new waterproof membrane.
