MICHIGAN DEPARTMENT OF TRANSPORTATION

STR 8250

CULVERT SAFETY INSPECTION REPORT

Facility MILL	Latitude / Longitude 42.8524 / -83.4463	MDOT Structure ID 634505000874B01	Structure Condition Fair Condition(6)	 
Feature KEARSLEY DRAIN	Length / Width / Spans 27.9 / 0 / 2	Owner City: ORTONVILLE(5050)		
Location IN ORTONVILLE	Built / Recon. / Paint / Ovly. 1966 / / /	TSC Oakland(23)	Operational Status A Open, no restriction(A)	
Region / County Metro(7) / Oakland(63)	Material / Design 3 Steel / 19 Culvert	Last NBI Inspection 09/28/2017 / MRNO	Scour Evaluation 8 Stable Above Footing

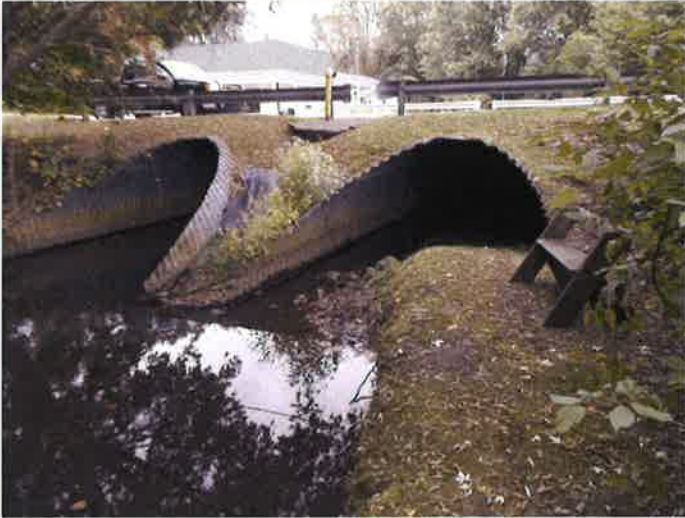
2. Channel (SIA-61)	6	6	6	All flow through west pipe. Channel is well vegetate with slight edge slumping. Geotextile fabric is exposed between culverts on south side with erosion occurring. (09/17) HMA pavement, minor cracks, no longer sealed. Raised concrete sidewalks along both sides of road, one panel in north walk has approx. 1" of settlement. Type A guardrail on steel posts, two panels on north side are impact damaged. Twin CMP arch culvert with bolted connections, 3 bolts missing in east pipe, rusting and light section loss at waterline, worse in west pipe. East pipe is filled with sediment with a grass covered peninsula on downstream end, no flow through this pipe. All flow through west pipe. Channel is well vegetate with slight edge slumping. Geotextile fabric is exposed between culverts on south side with erosion occurring. (09/15) Well vegetated. Slight edge slumping. E pipe is filled with sediment with a grass covered peninsula on downstream end, no flow through this pipe. All flow through W pipe. (09/13)

Document Name: DSCN0411.JPG
 Category: Elevation
 Comments: South elevation

Description
Replace riprap that has been washed away from the south end between culverts. Fix erosion on upstream end.

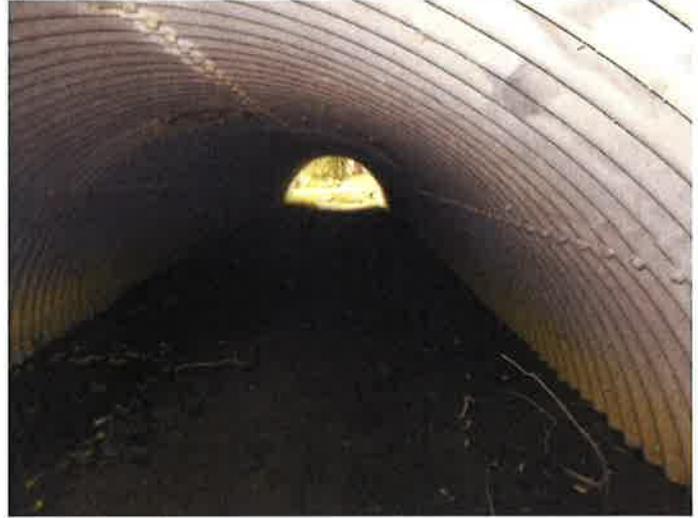
Twin CMP arch culvert with bolted connections, 3 bolts missing in east pipe, rusting and light section loss at waterline, worse in west pipe. Manhole in top of east pipe at south end. East pipe is filled with sediment with a grass covered peninsula on downstream end, no flow through this pipe. All flow through west pipe.

Document Name: DSCN0406.JPG
 Category: Culvert
 Comments: East culvert

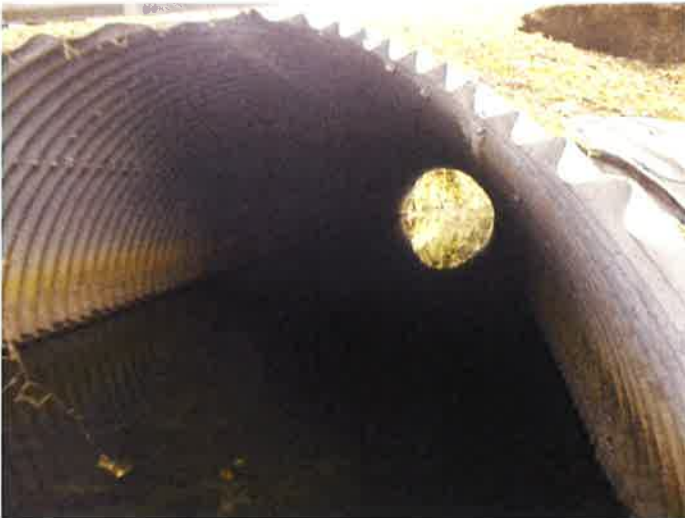
Document Name: DSCN0410.JPG
 Category: Culvert
 Comments: West culvert
